Tragedy in Hughson December 2011

Findings and Recommendations January 2013

Critical Incident Report

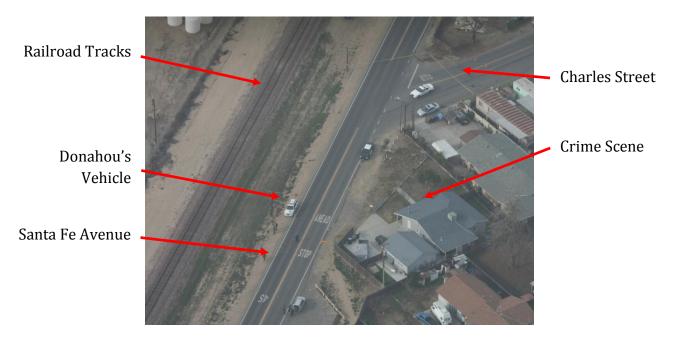
The collision occurred on Santa Fe Avenue south of Charles Street in Hughson. Santa Fe Avenue is a two lane, paved roadway with one lane in each direction separated by solid double yellow lines. The posted speed limit is 45 miles per hour.

West of Santa Fe Avenue is a single set of Union Pacific railroad tracks. On the east side of Santa Fe Avenue is an approximately 20 foot wide dirt area leading to a chain link fence and the single family residence at 2630 Santa Fe Avenue. Below is a photograph of the crime and traffic collision scenes.

Aerial View of Crime and Traffic Collision Scenes

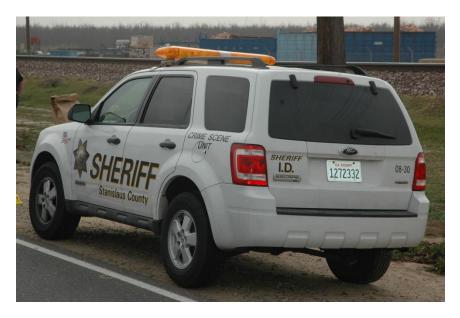
Donahou's Vehicle Parked on Santa Fe Avenue

The CHP MAIT investigators determined that Donahou parked her vehicle facing south on the west shoulder of Santa Fe Avenue. Donahou placed her vehicle in park, turned the ignition off, and activated the vehicle's parking lights. She exited her vehicle, wearing her SCSD CAT uniform, and obtained a camera from the vehicle's front passenger seat.

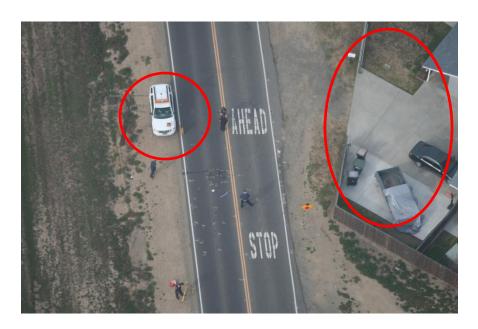
Donahou's Vehicle and Gunfire Crime Scene

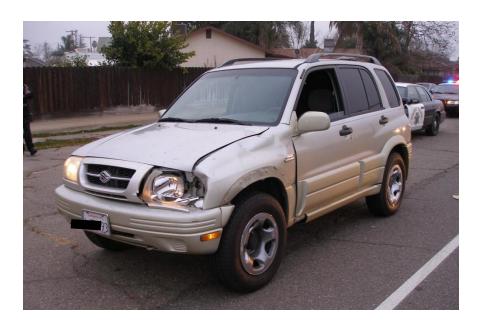
Donahou was first struck by the left front fender of Vehicle Two, causing her to be propelled into the driver side of Vehicle Three. The collision with the left side of Vehicle Three caused Donahou to be propelled back under Vehicle Two resulting in Vehicle 2 traveling over her with the left rear tire.

When the traffic collision occurred, a 38-year-old female was driving a four-door Suzuki southbound on Santa Fe Avenue from Charles Street.

2000 Suzuki, Grand Vitara - Vehicle Two

Vehicle Two, Suzuki - Functional upon the roadway; no pre-existing defects; low beam headlamps and marker lamps were on; and headlamps were in compliance with the California Vehicle Code.

On January 11, 2012, twelve days after the collision, CHP MAIT investigators took Vehicle Two to a level asphalt concrete roadway similar to the accident scene. It was found that Vehicle Two's left headlamp had been damaged during the collision. The majority of the left headlamp lens was missing; however, the remaining portions observed were similar in appearance to the right headlamp lens.

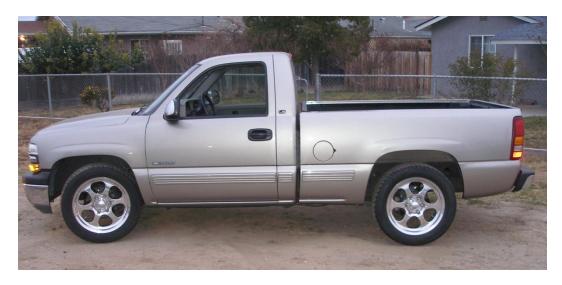
When the traffic collision occurred, a 48-year-old male was driving a Chevrolet pickup truck northbound on Santa Fe Avenue approaching Charles Street.

2000 Chevrolet Silverado - Vehicle Three

After CHP MAIT personnel arrived, it was determined that Party 3 should be contacted and Vehicle Three inspected. A CHP MAIT Investigator conducted a follow-up interview with Party 3 at his place of employment. The investigator examined Party 3's vehicle, and found evidence that Donahou collided with Vehicle Three.

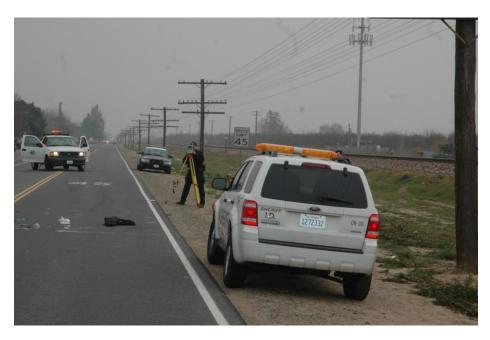
Finding No. 2 — Parking Too Close

Investigators determined that Mary Donahou's vehicle was parked one foot from the edge of Santa Fe Avenue with the vehicle's parking lights activated. Although this was a legal parking position, the spacing between the police vehicle and roadway presented danger when exiting. It was noted that additional parking space to the right was available.

Recommendation:

Civilian and sworn personnel need to be reminded that positioning a marked or unmarked police vehicle requires careful consideration. After evaluating multiple factors, the vehicle operator and passenger(s) must exit the vehicle in a cautious manner.
